**SI 0078**  
For technical personnel only!  
1/2

# SERVICE INFORMATION

## VACUUM PUMP DAMAGE DUE TO INCORRECT ASSIGNMENT

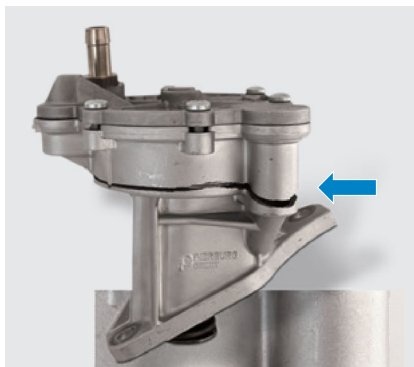
If an incorrect pump has been mounted, this will lead to breakage of the pump housing (see Fig. 1) during the initial engine start following installation, or even to breakage of the camshaft – and therefore to severe and expensive engine damage.

Fig. 1: Breakage in the pump housing

**In order to prevent damage, it is essential to check the chassis number, registration date and/or the part number of the old pump!**

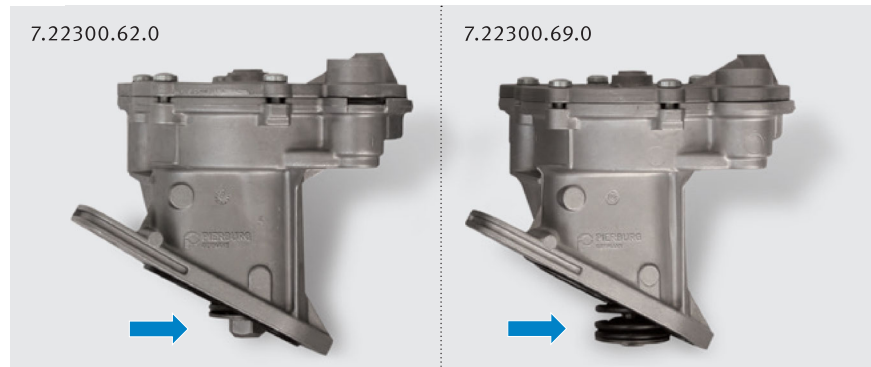
Fig. 2: Comparison of vacuum pumps

Vehicle: VW Transporter LT, T4 (platform, bus, truck, California), engine classification code: AAB		
Pierburg no.	7.22300.62.0	7.22300.69.0
Replacement for	7.22300.12.0	7.22300.19.0
Model year	up to 5/1994	from 5/1994
<b>Chassis number</b>	<b>up to 70-R-180 000</b>	<b>from 70-R-180 001</b>
VW part number	075 145 100; 075 145 101; 075 145 101 A	074 145 100 A
VW cylinder head no.	074 103 351 A	074 103 351 D
Motorservice cylinder head no.	50 003 101	50 003 113
Cylinder head cover surface	11 holes; Ø 5 mm	without holes
Pierburg tappet number	3.52124.06.0	3.52124.05.0
VW tappet number	075 145 307	074 145 307 B
Tappet length	71.0 mm	67.5 mm

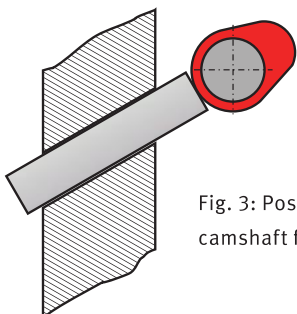
Fig. 3: Position of the camshaft for installation

In order to mount the pump with only a minimal amount of preload (max. 2 mm gap), the cam on the camshaft for driving the vacuum pump must be positioned on the opposite side of the connecting tappet (see Fig. 3) during mounting:

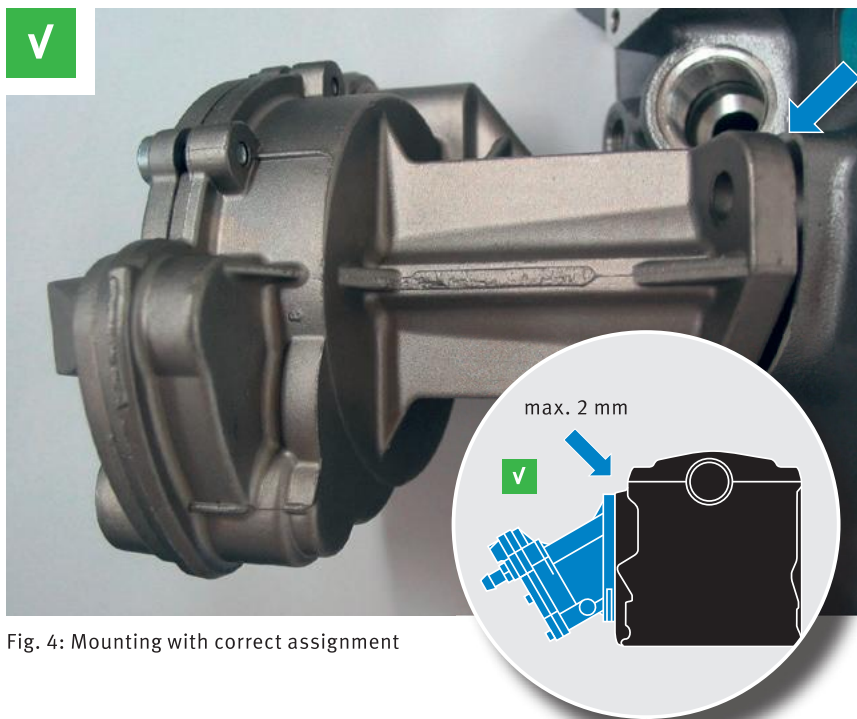
Fig. 4: Mounting with correct assignment

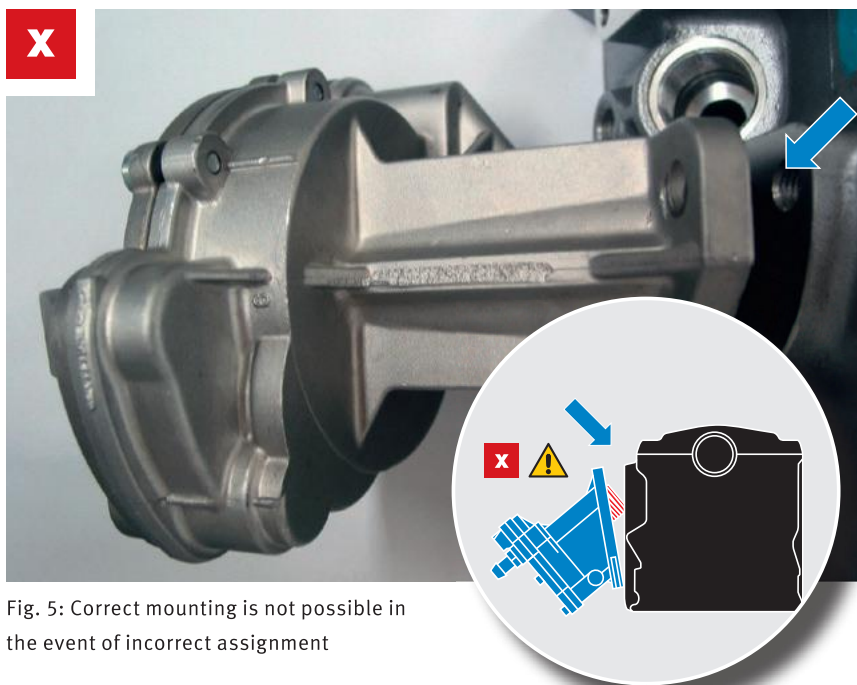
If it is not possible to press the vacuum pump to the flange (approx. 5 mm gap) without great effort, even with the cam on the opposite side of the connecting tappet, an incorrect assignment has very likely taken place.

Fig. 5: Correct mounting is not possible in the event of incorrect assignment

**It is essential to check the chassis number, registration date and/or the part number of the old pump! Never attempt to solve this problem by modifying the connecting tappet (e.g. regrinding)!**
